North Coast Regional Water Quality Control Board

Water Quality Inspection Report

Subject: Inspection Report for March 22, 2019, Consent Inspection of Humboldt County Assessor Parcel Numbers (APNs) 223-074-004-000 and 223-074-009-000

File: Cannabis Program Inspections, Humboldt County, WDID:1_12CC403261, CIWQS Place ID. 823853.

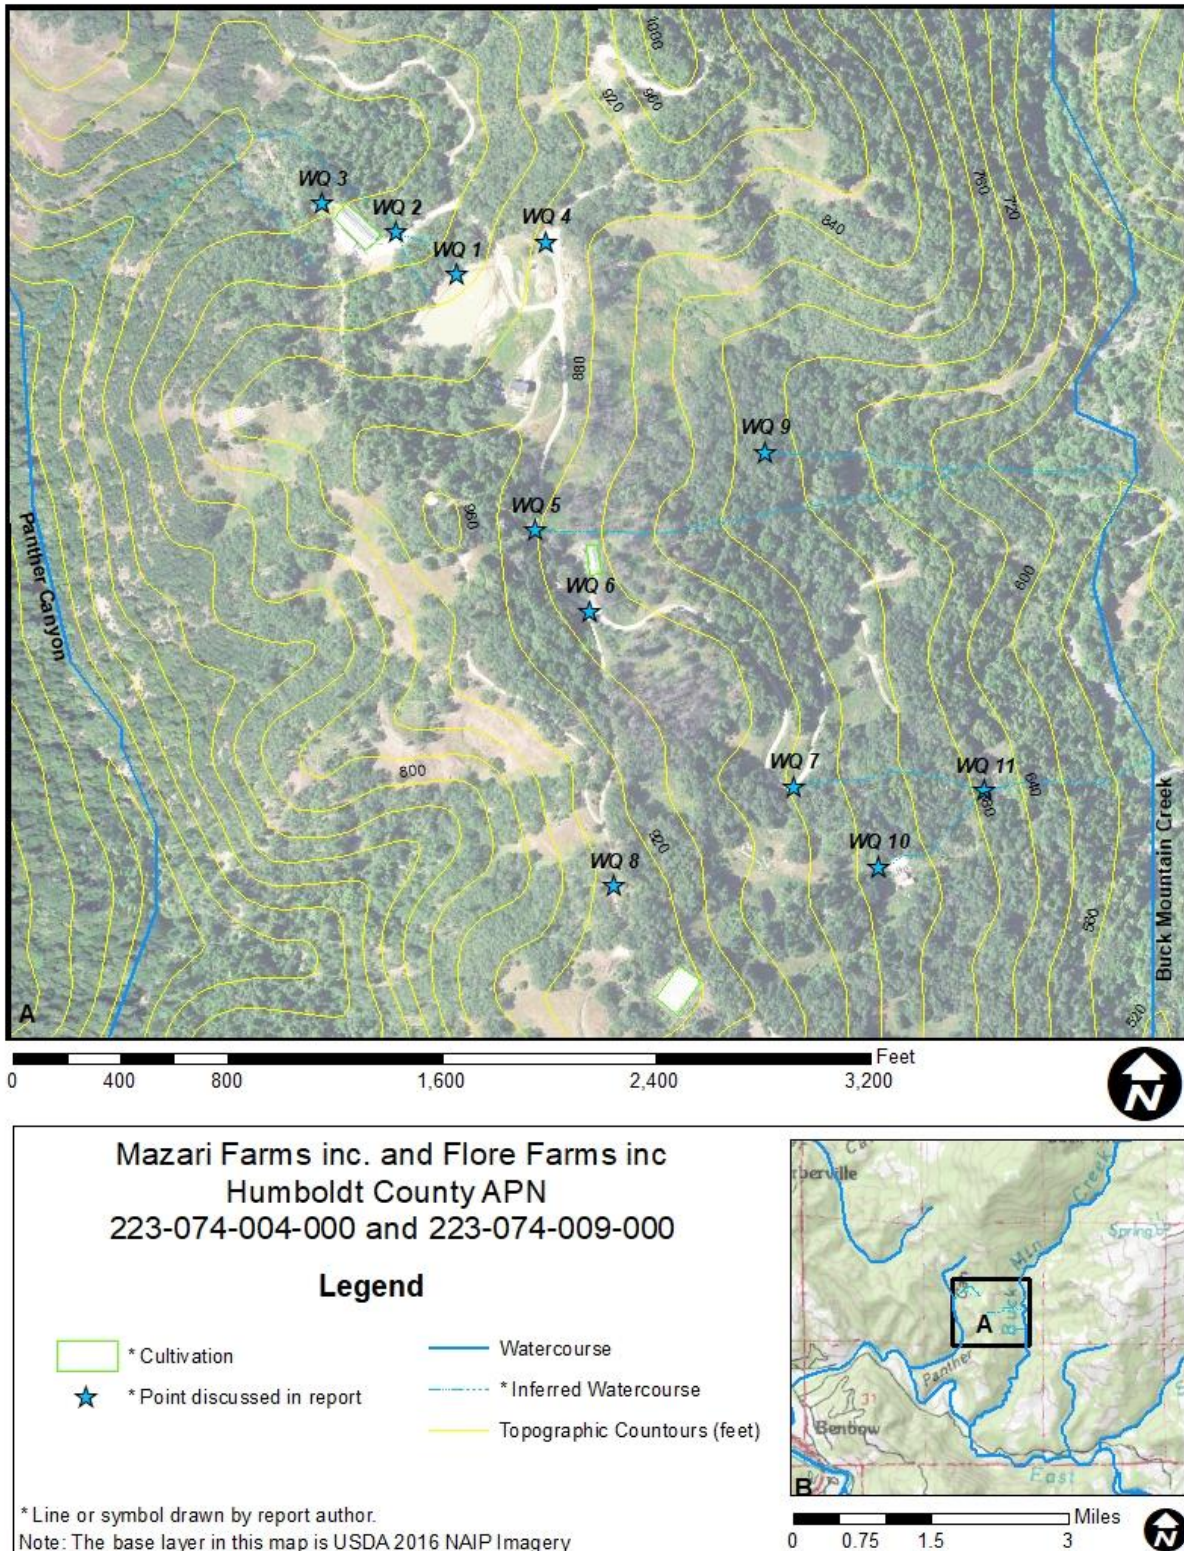
Inspection Map

Map A includes reference points for features of water quality, abbreviated WQ, interest discussed below. Map B shows Location of Map A relative to Garberville and Benbow.

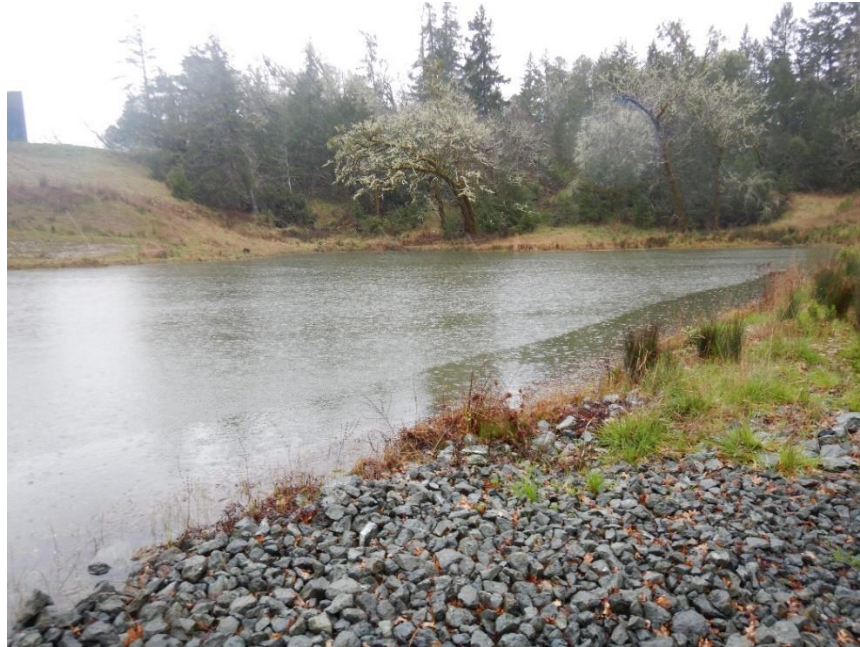
Inspection participants met at the intersection of Little Buck Mountain and Alderpoint Roads and then drove to a location east of the Enlarged Pond. We walked on top of the dam at *WQ 1*, and I noted that there had been no apparent changes to the dam since the preceding year; the water level was near to the dam crest (*photo 1*) and there were tension cracks apparent on the dam crest (*photo 2*). I observed a concave-up feature on the outboard face of the impounding dam within the region of the tension cracks (*photo 3*). In discussion with Mr. McKnight about the scope of work required to restore the enlarged pond area, staff recommended that a geologist perform a site assessment, and that Mr. McKnight refer to this geologic site assessment in developing his engineering plans, and ask the geologist to review the engineering plans to verify that any concerns he had were addressed. We also agreed that an adequate restoration of the site may include retaining/installing a smaller pond somewhere within the footprint of the impacted area. I asked Mr. McKnight if he had an estimate of the pond dimensions and he said it was no more than 37,600 square feet and contained no more than 300,000 gallons of water.

photo 1 – Looking south from the enlarged pond spillway at WQ 1.

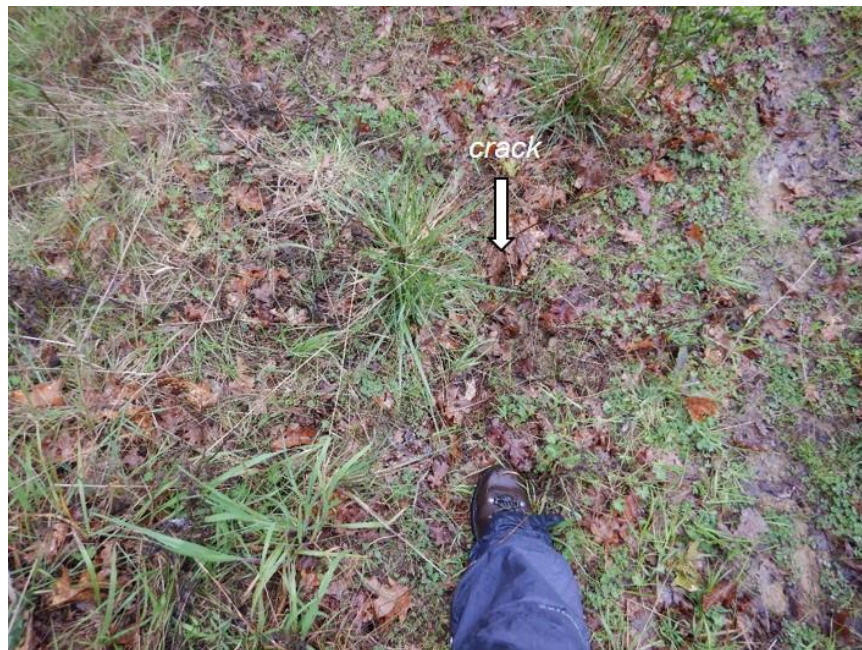
photo 2 – Looking at tension crack on crest of the enlarged pond impounding buttress west of WQ 1.

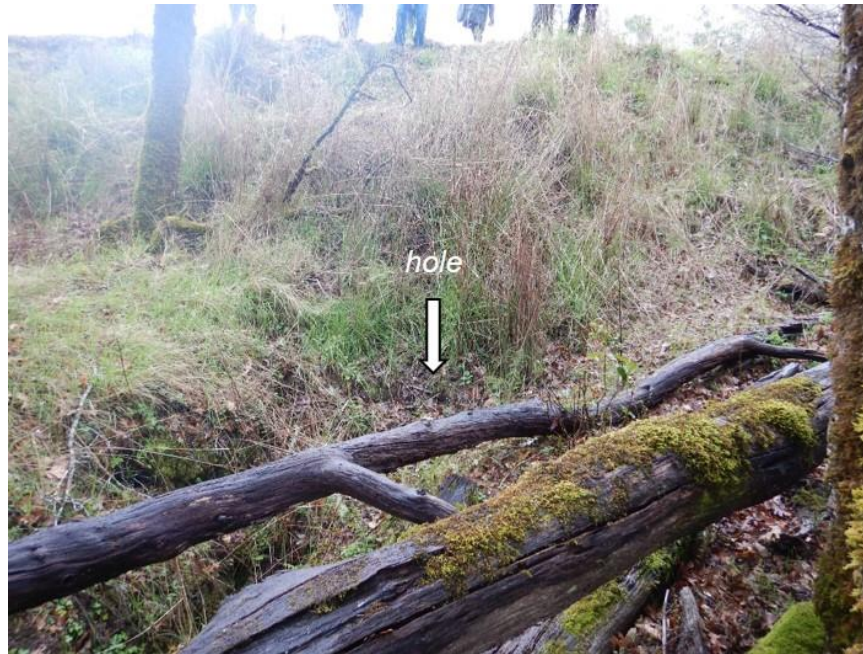
photo 3 – Looking at concave-up feature (hole) on the outboard face of the impounding dam within the region of the buttress with tension cracks pictured in photo 2.

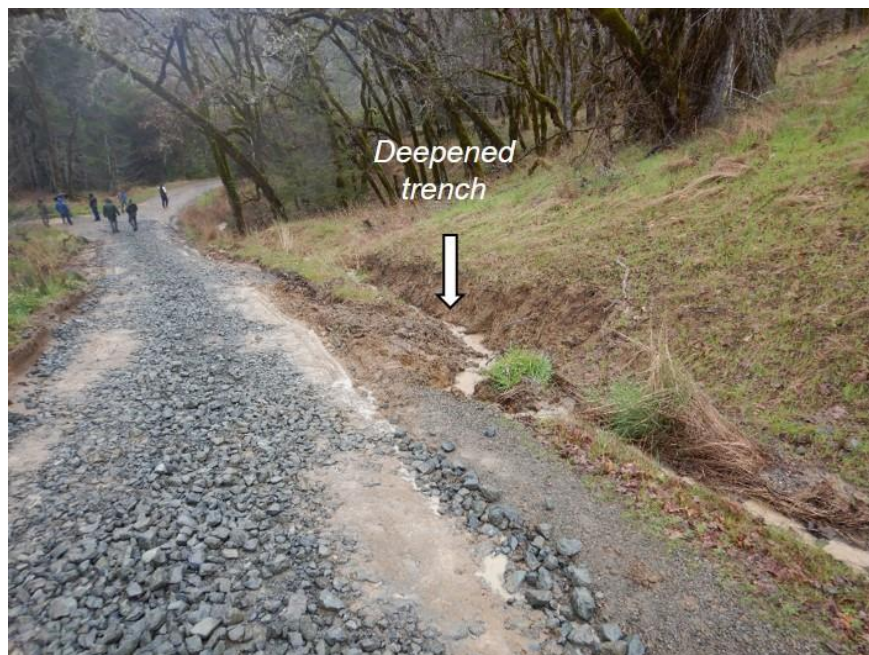
We left the dam and returned to the road bordering the east side of the Enlarged Pond. I noted that the trench on the west side of the road had deepened since the 2018 inspection (*photo 4*). The road had been rocked, however the rock appeared to be sinking into the road substrate (*photo 4*). I asked Mr. Kindred, the ranch manager, when the road had been rocked, and he told me the rock was added three to four days earlier. We then proceeded west down the road leading to the Glass House. The trench on the north side of the road appeared to have been recently scraped (*photo 5*), however, no work had been performed to disconnect the road drainage from receiving watercourses (*photo 6*). In the parking areas south of the Glass House, some of the materials had been covered (*photo 7*), however, stormwater continued to mix with potting soils on the west side of the Glass House (*photo 8*), and I observed a large amount of spent potting soils piled north of the Glass House where they had the potential to discharge into tributaries to Panther Canyon less than 100 feet to the east (*photo 9*).

photo 4 – Road on east side of enlarged pond. Note incising trench adjacent to road and rock on road surface sinking into saturated fine material.

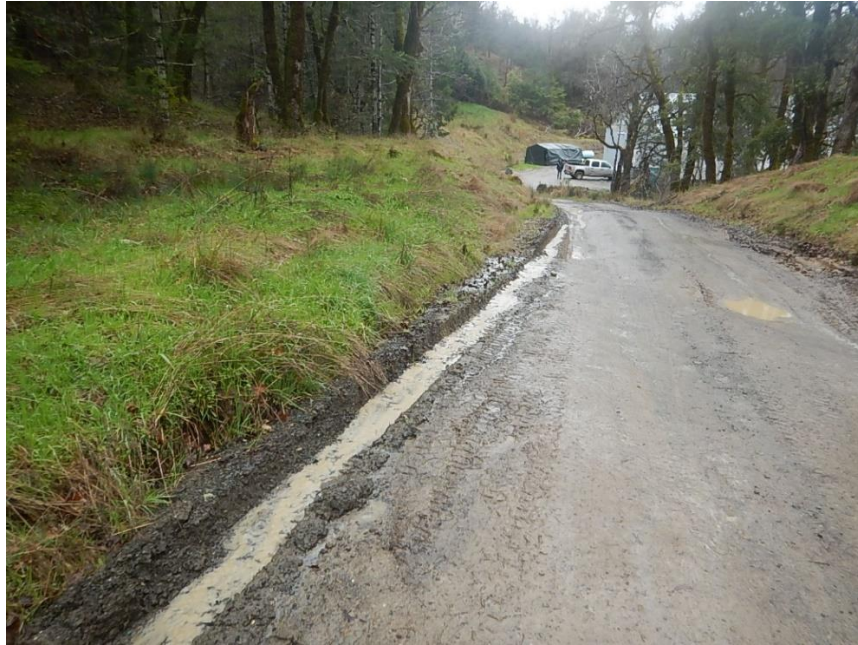
photo 5 – Road runoff directed into trench discharging to watercourse east of Glass House pictured in photo 6 below.

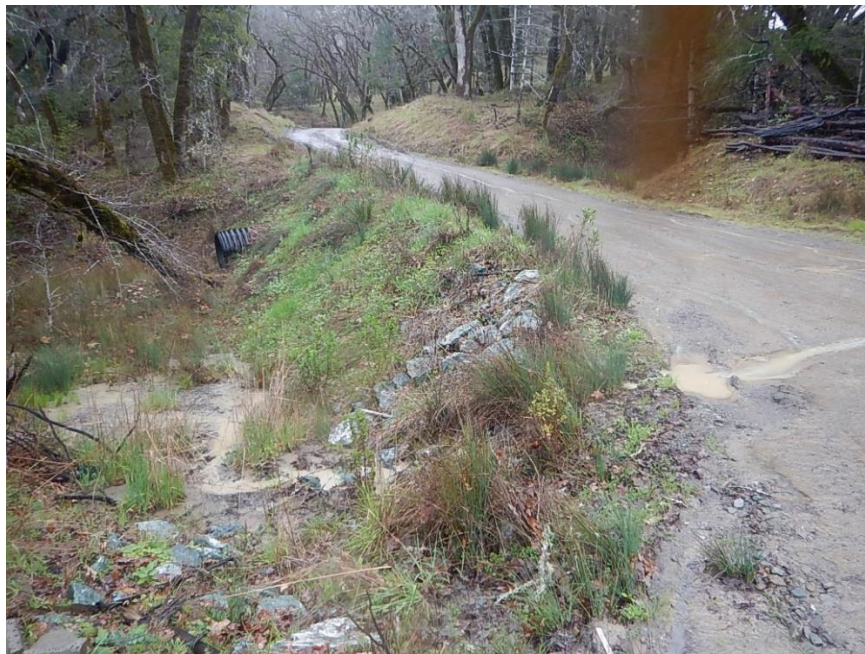
photo 6 – Looking east at road runoff directed into watercourse east of Glass House at WQ 2.

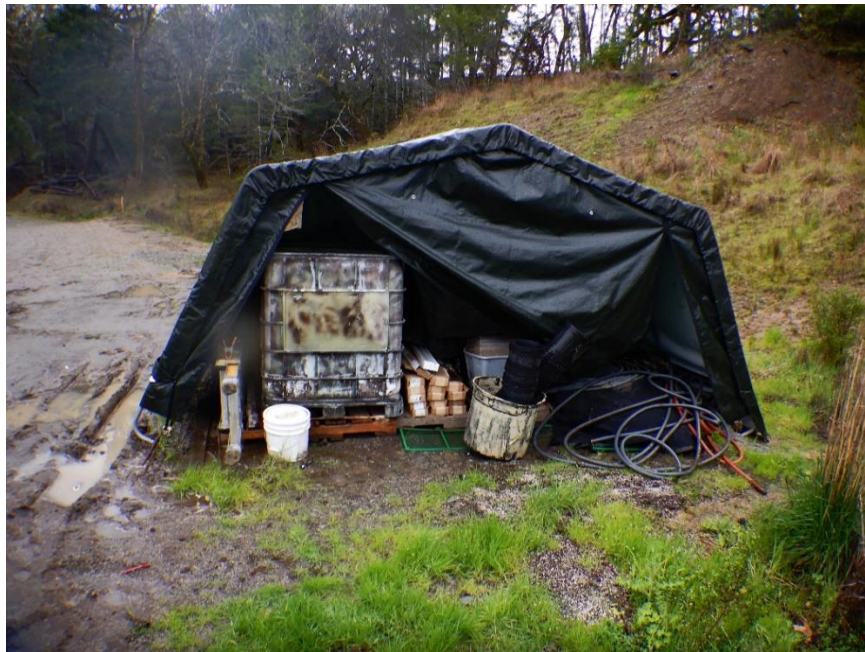
photo 7 – Materials covered northwest of Glass House.

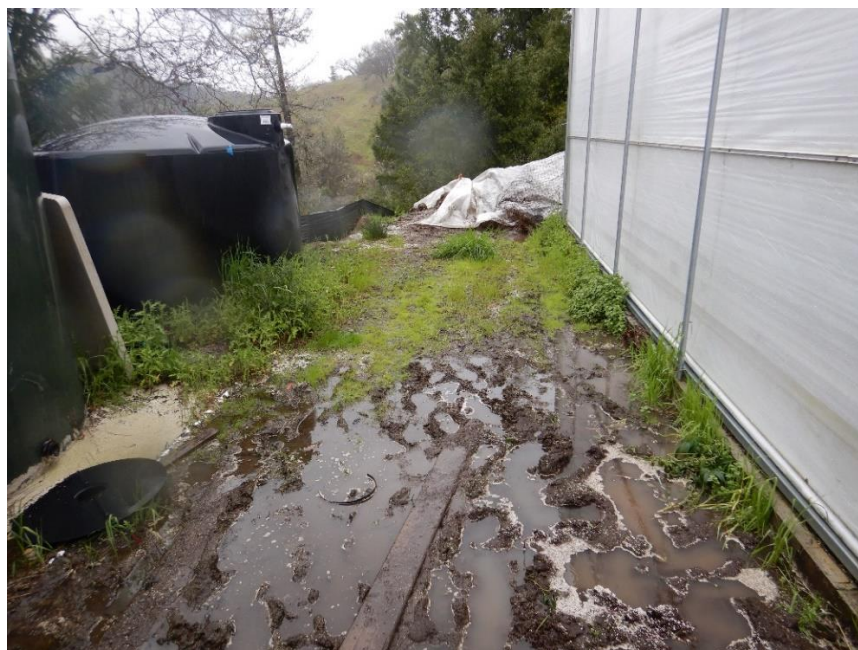
photo 8 – Storm water mixing with potting soils west of Glass House.

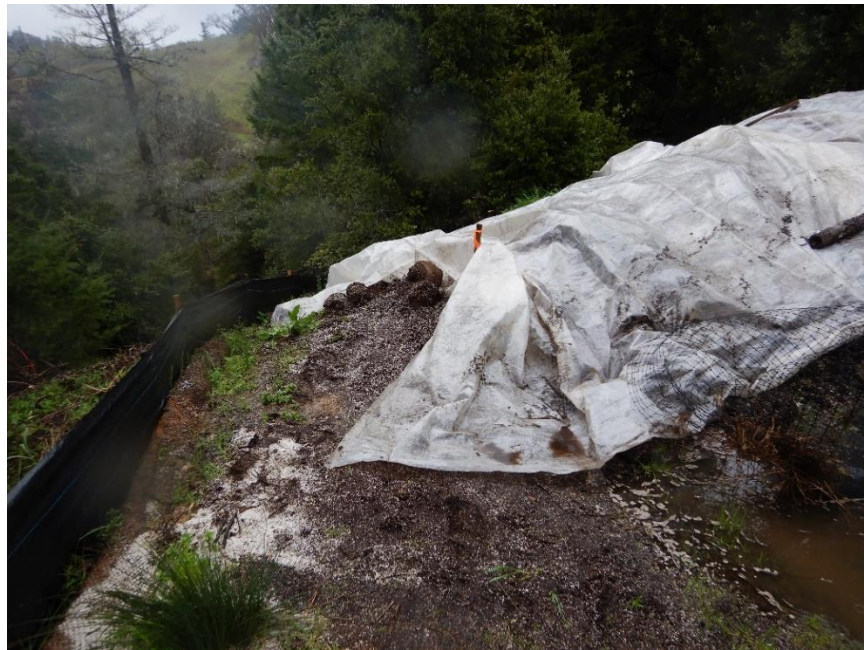
photo 9 – Large pile of potting soils north of Glass House, and upslope from water, WQ 3.

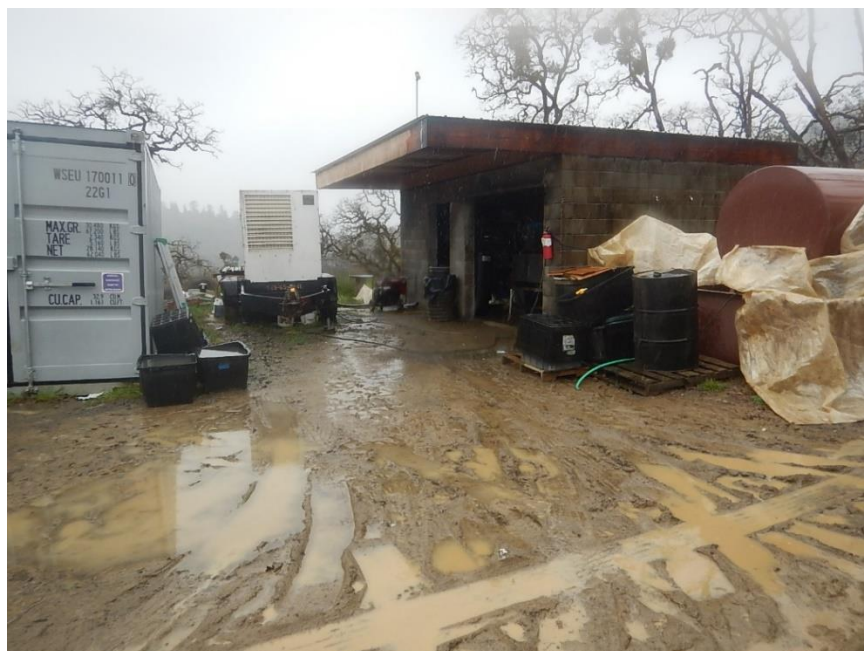
During the inspection, we saw a recently-installed roof above the generator building (*photo 10*), however, the roof appeared to be unfinished (*photo 11*), allowing stormwater to mix with fuels in the generator building. We also inspected the cannabis cultivation area south of the Enlarged Pond, and east of *WQ 5* and *WQ 6* (*photos 12 and 13*). Here, the graded pad was rocked and materials for a new building had been stockpiled. I did not observe any evidence that work had been done to address water quality concerns with the road (*photos 12, 14, 15 and 16*). We walked to the Shady Grove site, where conditions were similar to those we had observed during the 2018 inspection (*photos 17 and 18*), with the exception that a relatively small amount of potting soils had been pulled away from a watercourse and covered with plastic (*photo 19*). We also inspected a group of small cabins, located at *WQ 10*, that occupied the same watercourse as they had during the 2018 inspection (*photo 20*), and we observed that the culvert downstream from two incising watercourses at *WQ 11* had not been corrected (*photos 21, 22, 23*).

photo 10 – Generator and fuel storage building, at WQ 4, with new roof.

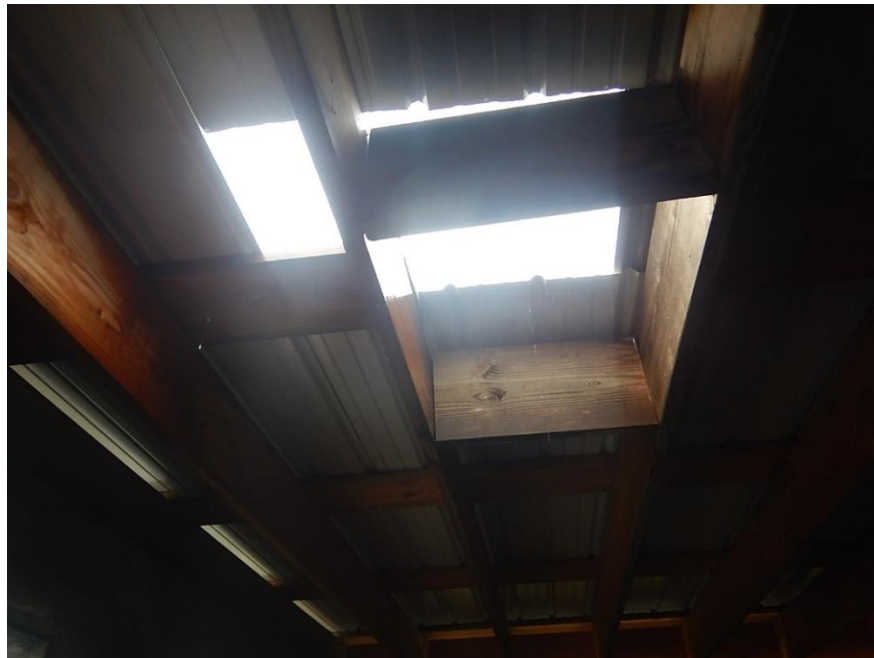
photo 11 – New roof on generator building, WQ 4, pictured in photo 10 above, is unfinished and allows stormwater to mix with fuels in generator building.

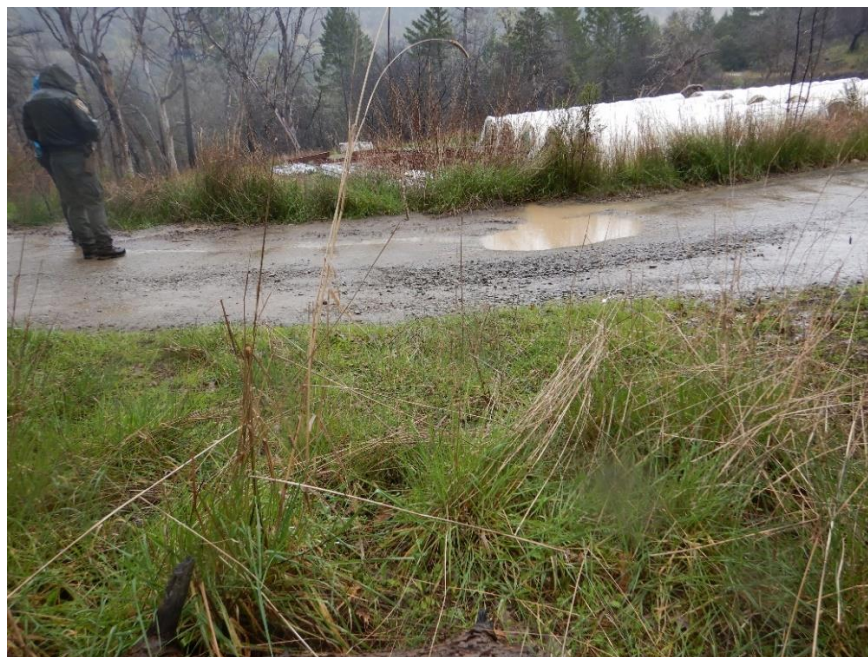
photo 12 – Looking east above blocked culvert crossing at WQ 5.

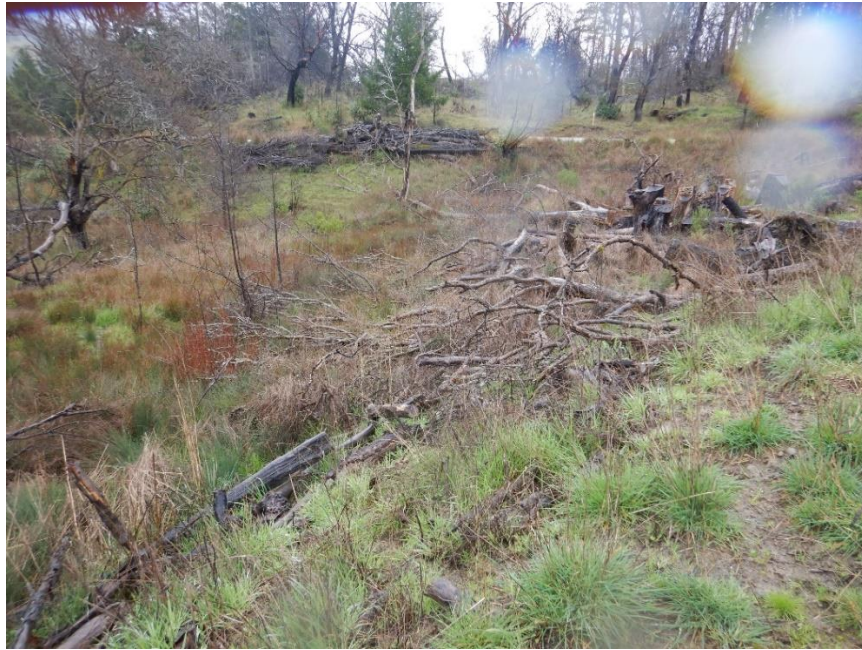
photo 13 – Looking south at suspected wetland southeast of WQ 5 and north of WQ 6.

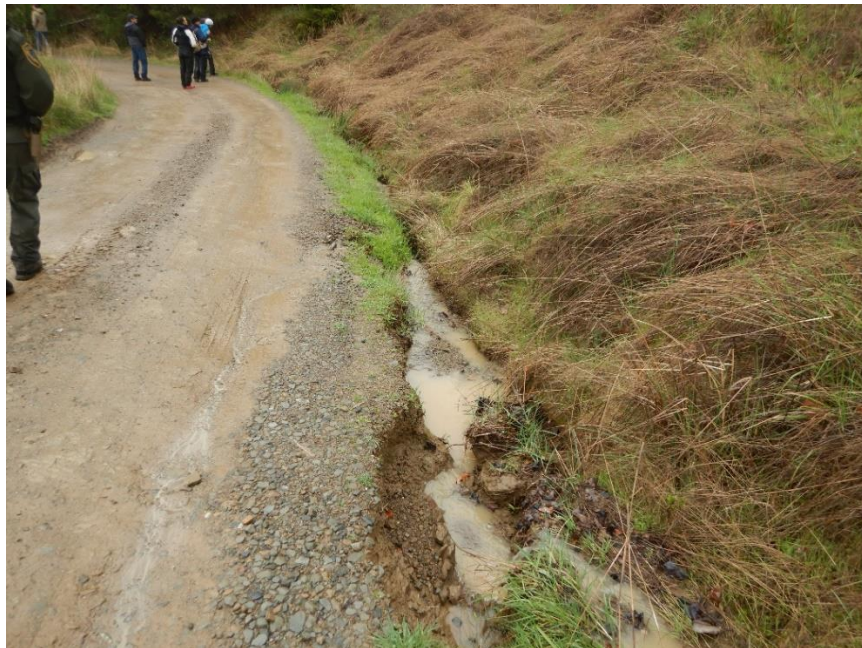
photo 14 – Stormwater is incising inboard ditch that starts at WQ 6 and delivers to watercourse at WQ 7.

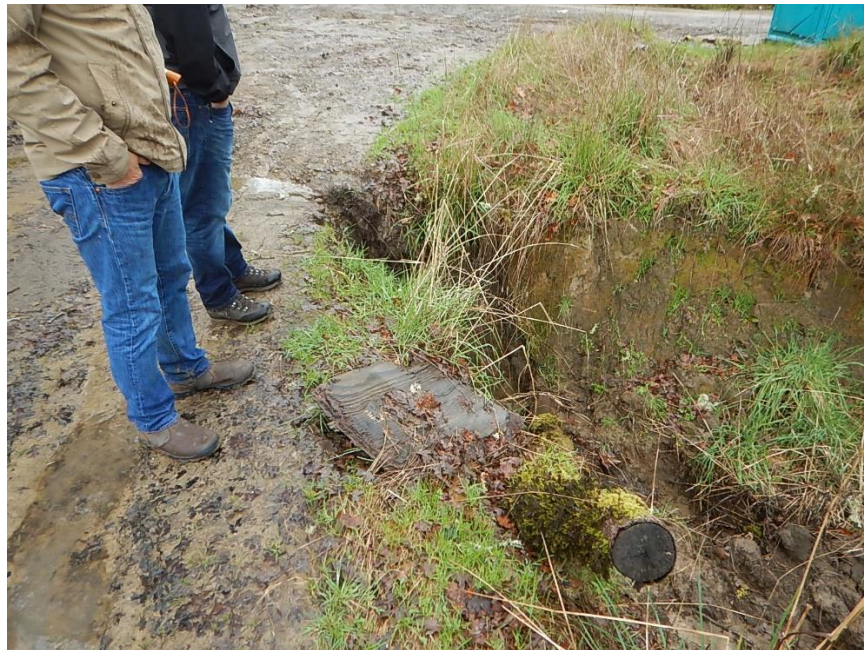
photo 15 – Road runoff delivering to watercourse at WQ 7.

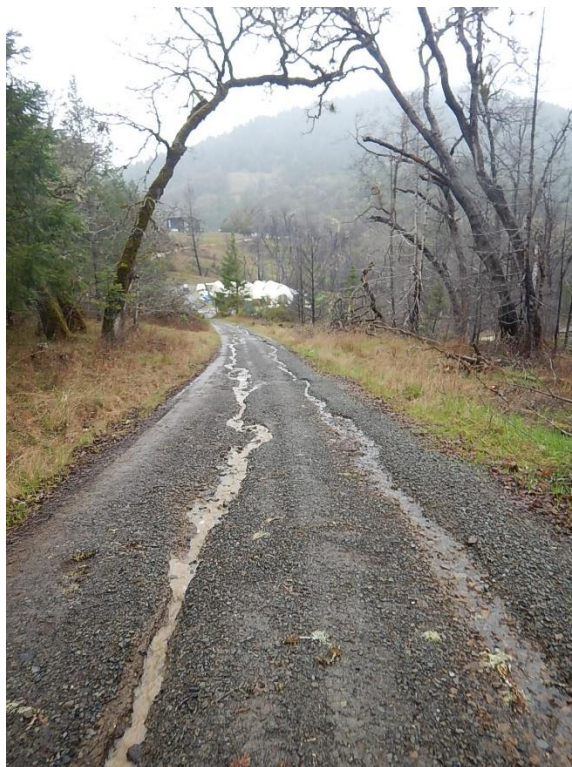
photo 16 – Water flowing down road surface from WQ 8 and contributing to ditch at WQ 6.

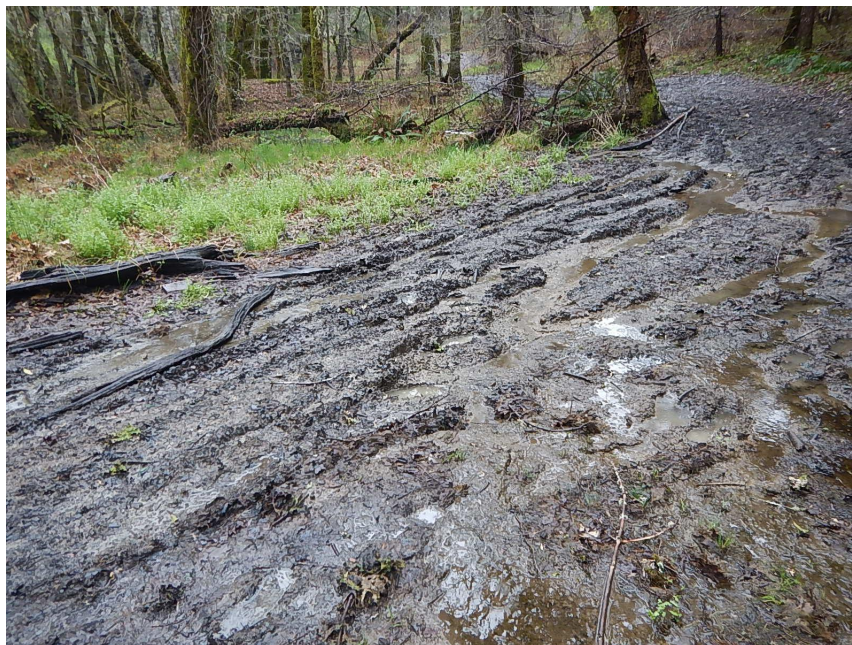
photo 17 – Water flowing over road leading to WQ 9.

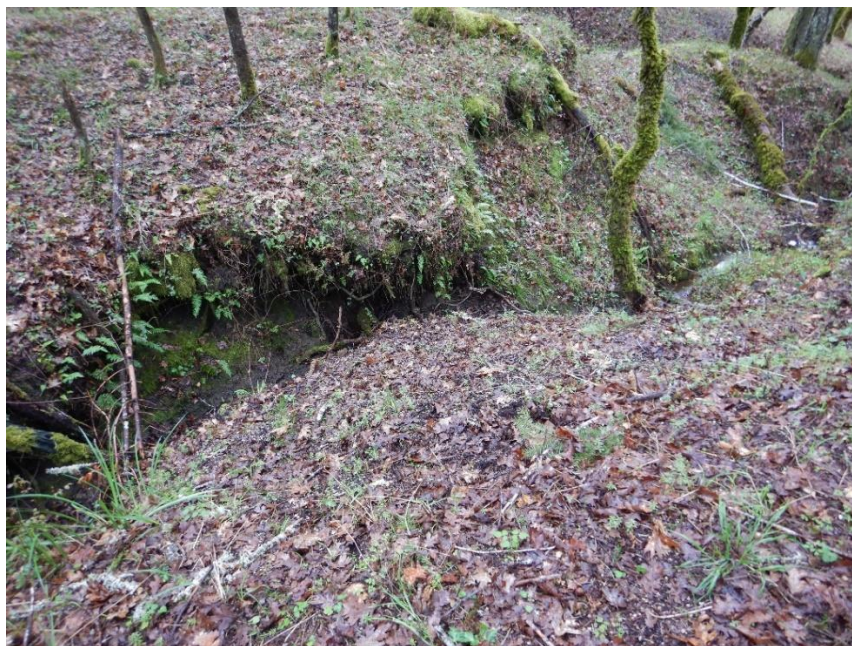
photo 18 – Potting soil disposed of in watercourse at WQ 9.

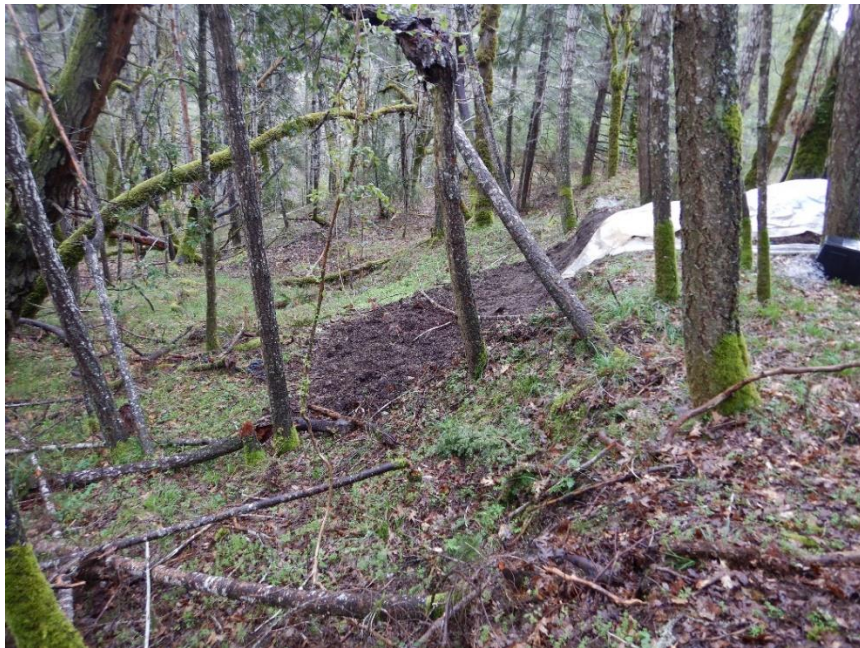
photo 19 – Upper right of image shows that some potting soil had been collected near WQ 9, and is now covered with plastic.

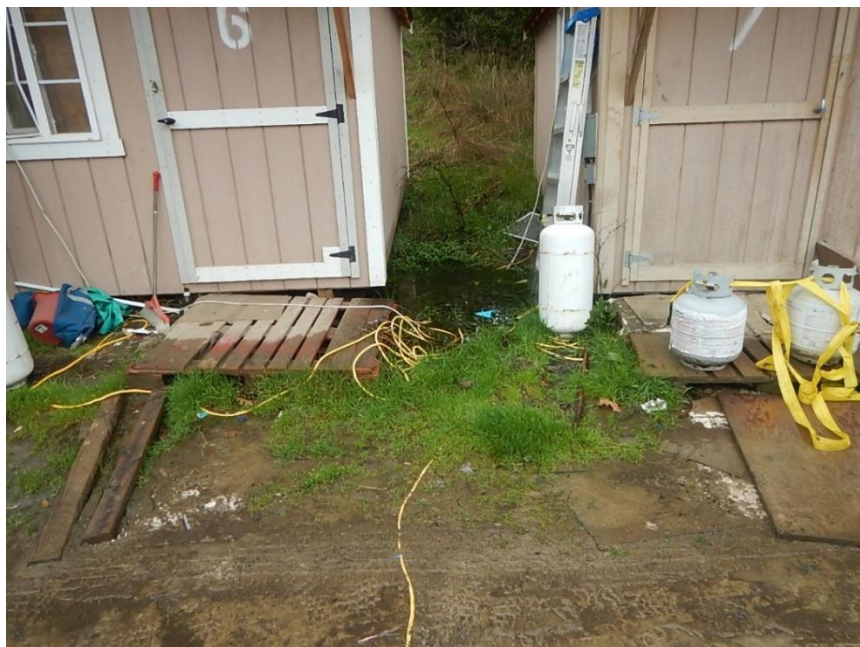
photo 20 – Water flowing past and underneath sheds at WQ 10.

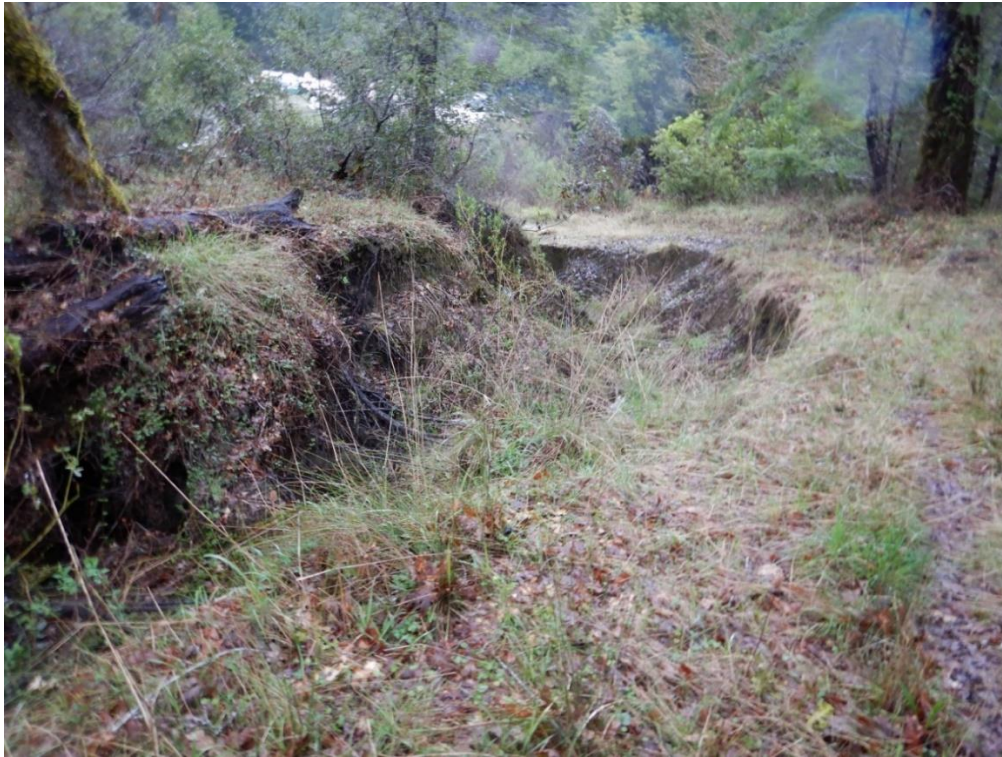
photo 21 – Gully upstream and west of WQ 11.

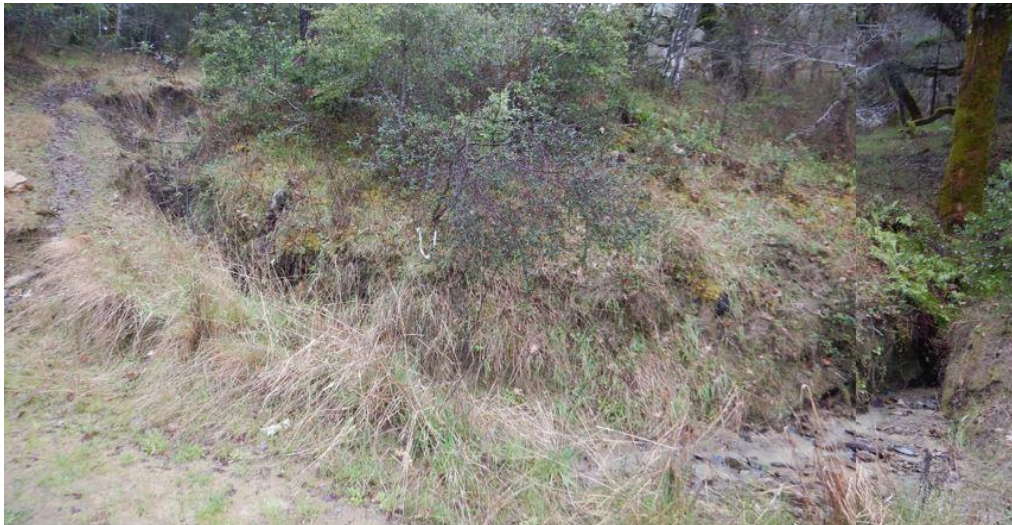
photo 22 – Looking west and upstream at the confluence of two watercourses from WQ 11. The water course pictured in photo 21 is shown in the left of this image. The two watercourses flow through one culvert, the outlet of which is shown below in photo 23.

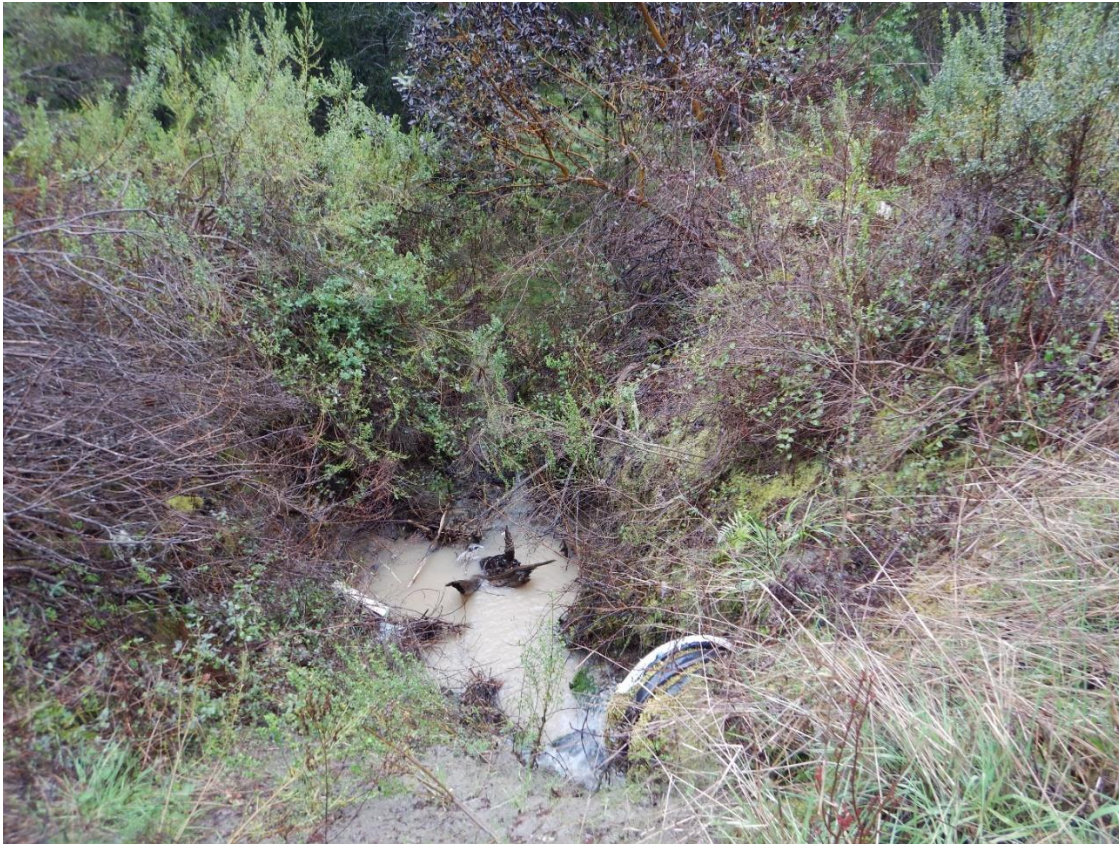
photo 23 – Outlet of culvert located at WQ 11.
